**Flood Control Project Maintenance
Levee Inspections**

Maintenance Issue Types Only, Levee Inspection Report By Mile - Spring 2017

Sacramento River West Side Levee District

Waterway	Bank	Unit Miles	Inspection Start/End	Inspector
Unit No. 01 Sacramento River	Right	49.64	03/21/2017 03/22/2017	Zach Jojola

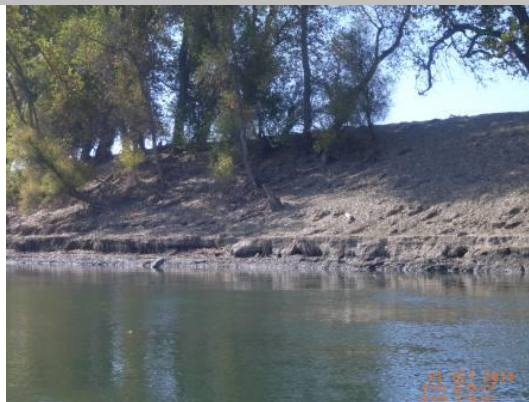
Photo 1 of 1 : SP_2017_NA0016_435_4_20170320_00004.jpg

LM Start	42.90	Rating **	A/W	Issue No.	4
LM End	43.09	Issue Type +	Ma	Location *	WS
Category	Supplemental			GPS Latitude/Longitude	
				Start	End
Item	2015 USACE Erosion Survey, DRAFT			39.172501 °	39.174949 °
				-121.939053 °	-121.940737 °
DWR ID	DWR_NA0016_01_s_2016_4				
Comment Code					
Inspector Comment					
2010 - Lower portion of 136.7 that did not extend far enough. Abrupt transition from upstream site. 2012 - Site extended upstream, minor new erosion. 2013 - Minor new erosion at the toe. New tree popout. Downstream limit extended. 2015: No observed changes. [2015 Site ID: SAC_136-6_R]

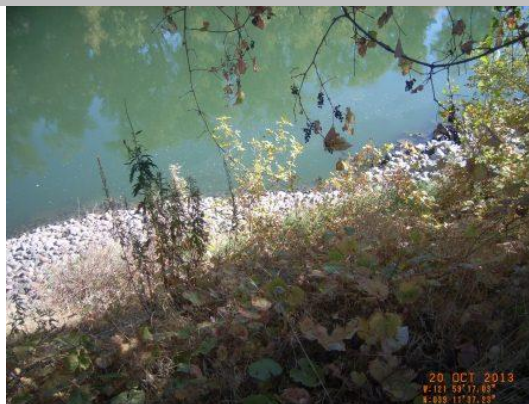
Photo 1 of 1 : SP_2017_NA0016_435_3_20170320_00003.jpg

LM Start	47.62	Rating **	A/W	Issue No.	3
LM End	47.77	Issue Type +	Ma	Location *	WS
Category	Supplemental			GPS Latitude/Longitude	
				Start	End
Item	2015 USACE Erosion Survey, DRAFT			39.193769 °	39.195595 °
				-121.987901 °	-121.988621 °
DWR ID	DWR_NA0016_01_s_2016_3				
Comment Code					
Inspector Comment					
2010 - Old cobble site starting to unravel at toe. 2011 - Cobbles continue to unravel. 2013 - Site extended downstream to revetment. 2015: No observed changes. [2015 Site ID: SAC_141-5_R]

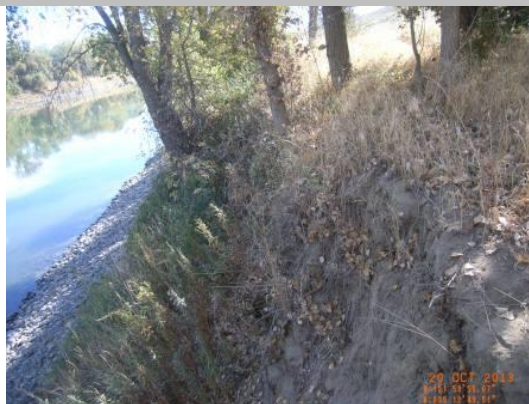
Photo 1 of 1 : SP_2017_NA0016_435_19_20170320_00018.jpg

LM Start	49.46	Rating **	M	Issue No.	19
LM End	49.57	Issue Type +	Ma	Location *	WS
Category	Supplemental			GPS Latitude/Longitude	
				Start	End
Item	2015 USACE Erosion Survey, DRAFT			39.213608 °	39.213869 °
				-121.997543 °	-121.999641 °
DWR ID	DWR_NA0016_01_s_2016_19				
Comment Code					
Inspector Comment					
2011 - Multiple scallops, one tree pop out. Old cobble site starting to unravel at midbank. 2012 - Mid bank slumping continues to worsen but cobble at the toe appears stable. 2015: No observed changes. [2015 Site ID: SAC_143-5_R]

USACE 2013 Photo #1
